WARNING

Improper re-fitting of the ABS sensor cable can cause the ABS system to malfunction hence leaving the bike without brakes!

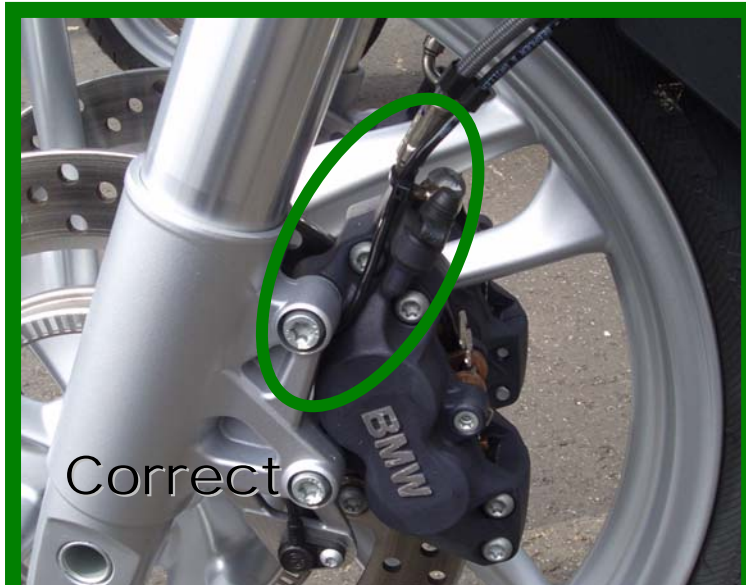
Correct Fitting:

The ABS Sensor cable is routed between the calliper and the two fastening bolts. This fitting is not obvious but it completely eliminates the possibility for the cable to get in contact with any moving parts, such as the brake disk.

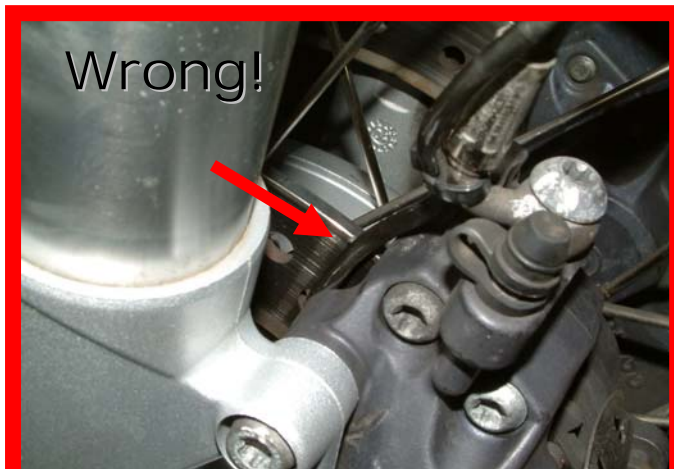
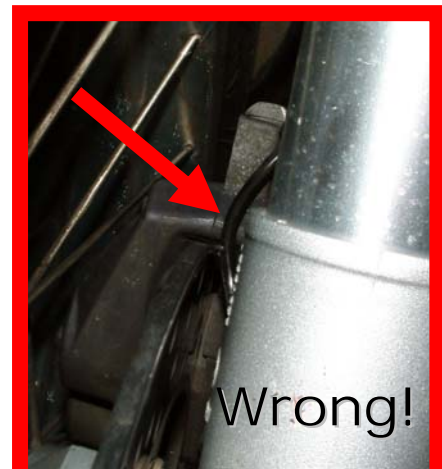
Incorrectly fitted ABS Sensor Cable:

The cable has been fitted so that it avoids the calliper – this seems to be the most logical way to fit the cable – *but it is not the right way*. This way the cable can come in contact with the brake disk. The thin plastic shielding is quickly ground through and short circuits the signals transmitted from the sensor to the on-board computer. Although the ABS system *will eventually fallback to turning the ABS functionality off*, *this will only happen once the computer has discovered there is a problem*. **Before this happens the ABS system might be lead to believe that the front wheel has stopped which in turn means the ABS system will release braking-pressure (to get the wheel spinning again) rendering the bike without any braking power.**

This is **NOT** a fool proof system design.
